CHAPTER 10

ULF FRANSSON

A farmstead from the late Viking Age and early medieval period. House constructions and social status at Vik, Ørland

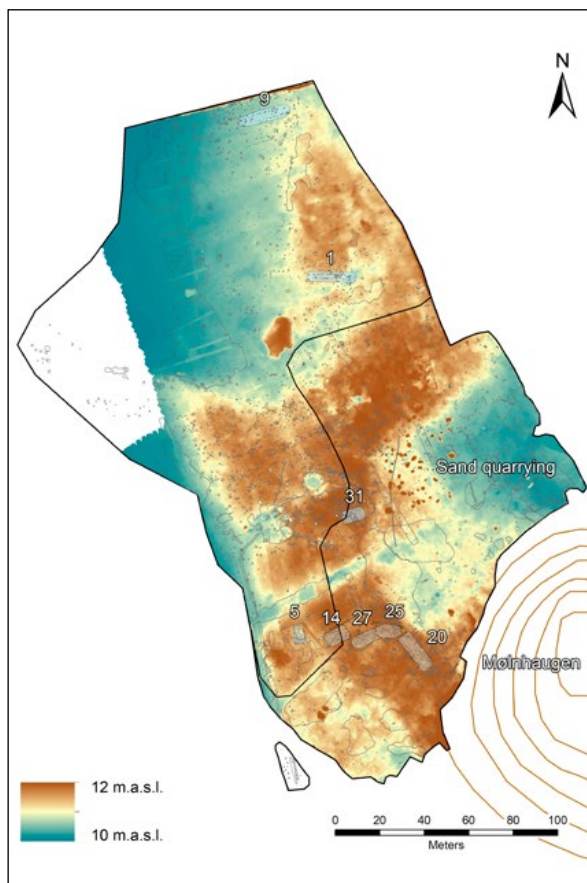
Figure 3. Topographic model over Fields A and E, Vik. In the western part of the model, the ground is disturbed by a modern gravel pit. Illustration: Magnar Mojaren Gran.

Most of the remains on the southern part of Field E were found on two narrow elevation ridges. One extended in a north-south direction over both Fields E and A. On that ridge a variety of cooking pits, wells, ditches as well as Houses 20 and 25 were excavated. The other ridge stretched in an east-west direction from House 25 and sloped gently down to the wetlands in the west. On the east-west ridge, cooking pits, wells, ditches and Houses 5, 14 and 27 were excavated (Figures 3 and 4).

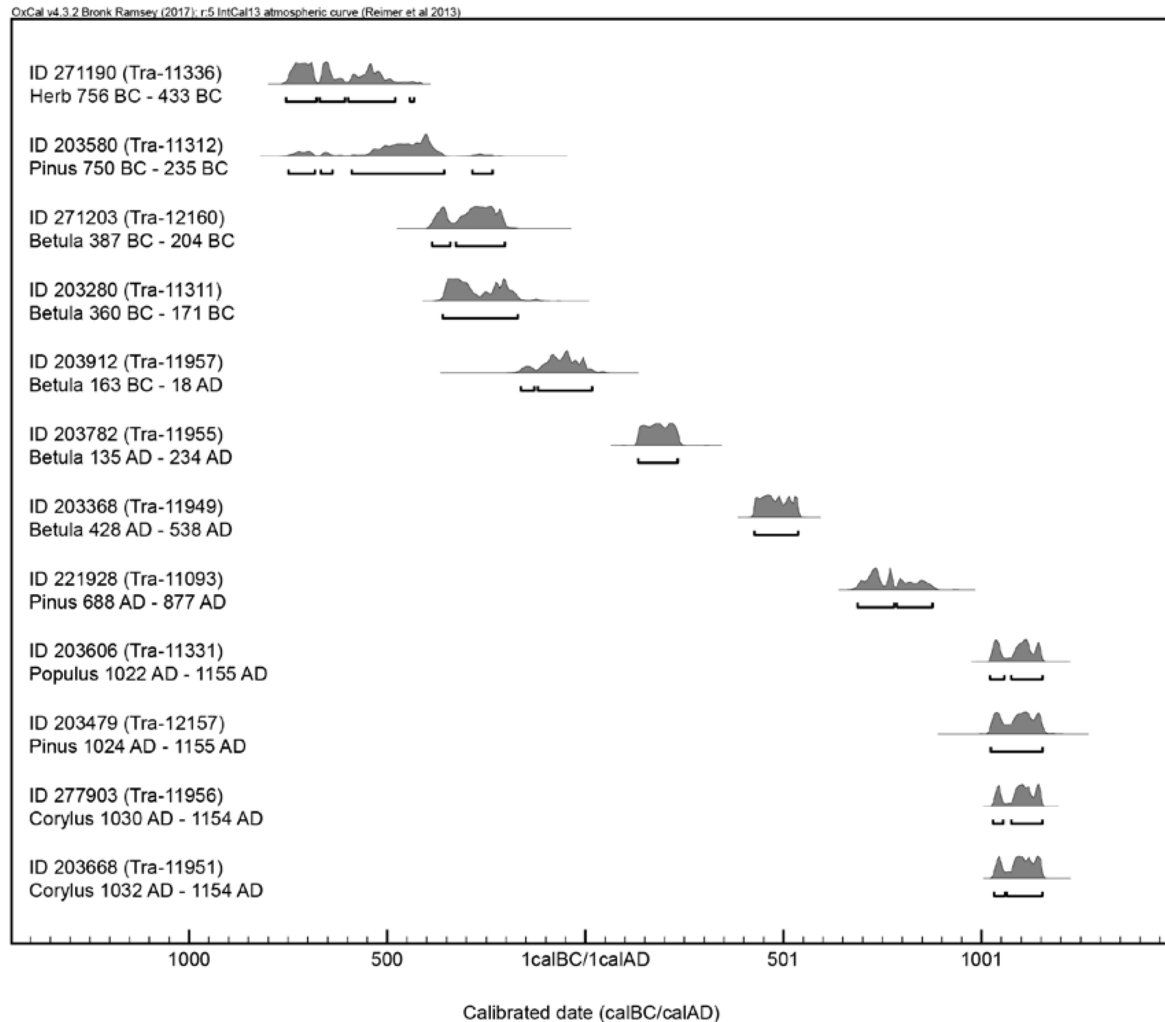
Figure 4. Radiocarbon dates from House 20, Vik. Illustration: Magnar Mojaren Gran, NTNU University Museum.

However, the plateau in the calibration curve affects these dates, and House 20 can therefore not be dated more accurately than to the 200-year period from AD 1000 to 1200 (Fransson & Mokkelbost 2018: 287–288, Figure 6.35).

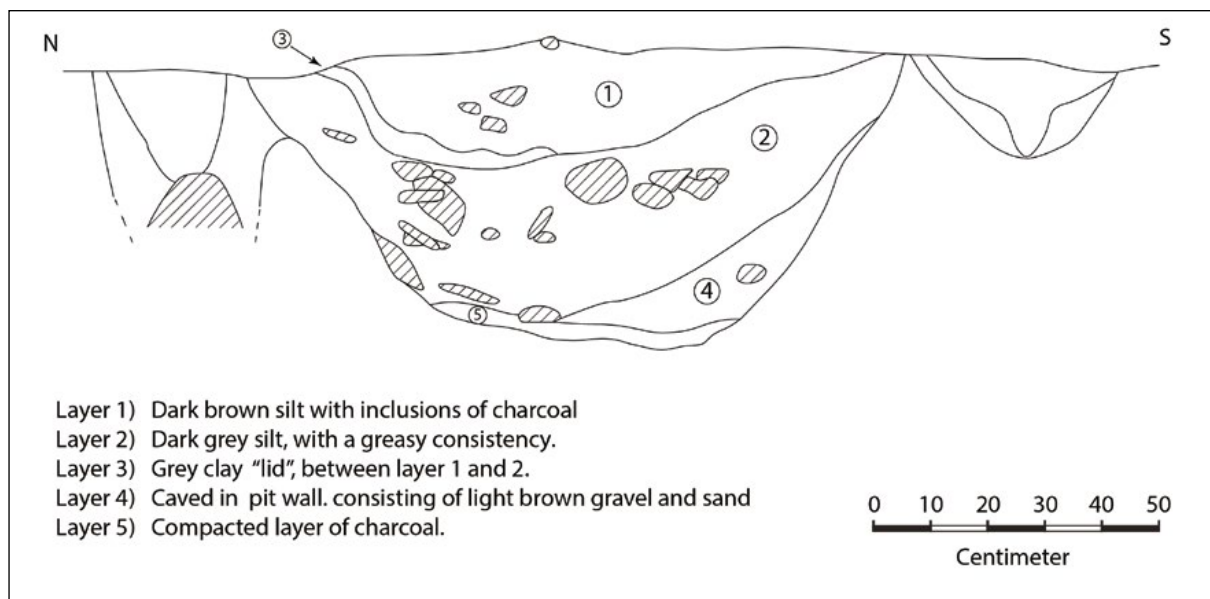
Figure 6. Waste pit 270600, profile. Illustration: Magnar Mojaren Gran, NTNU University museum.

The waste pit id. 270600 had been sealed with a layer of clay (Figure 6, Layer 3). The latest layer deposited under the clay is Layer 2. It is ¹⁴C-dated on charcoal from birch, c. three annual growth rings under the bark, to AD 1046–1214 (TRa-11102, 890±20 BP). In Layer 2 a button of amber (T:27403:2) and some continental ceramic shards (T:27403:18) were found (Figure 7). The shards were unglazed with an earthenware similar to stoneware typical for the continental Paffrath ceramics. The type constitutes a subgroup under the Pingsdorf ceramics, and was

The Paffrath type ware is important because it indicates that the farm still existed around 1200 AD. Layer 1, above the clay layer, is ¹⁴C-dated to AD 1056–1155 (TRa-11101, 950±20 BP). It is likely to have been a secondary culture layer, containing material from the farm which has been deposited on the clay layer at a later occasion. The dates from both Layer 1 and 3 lie in the time span of the plateau between AD 1050 and 1200. This strengthens the interpretation that the Paffrath type vessel had not been used for a long time before it was deposited. It was part of a sealed waste layer deposited during the early medieval period. There are also very few dates from the site from the 13th and 14th centuries. Together, all these dating results indicate that the farm was abandoned during the first decades of

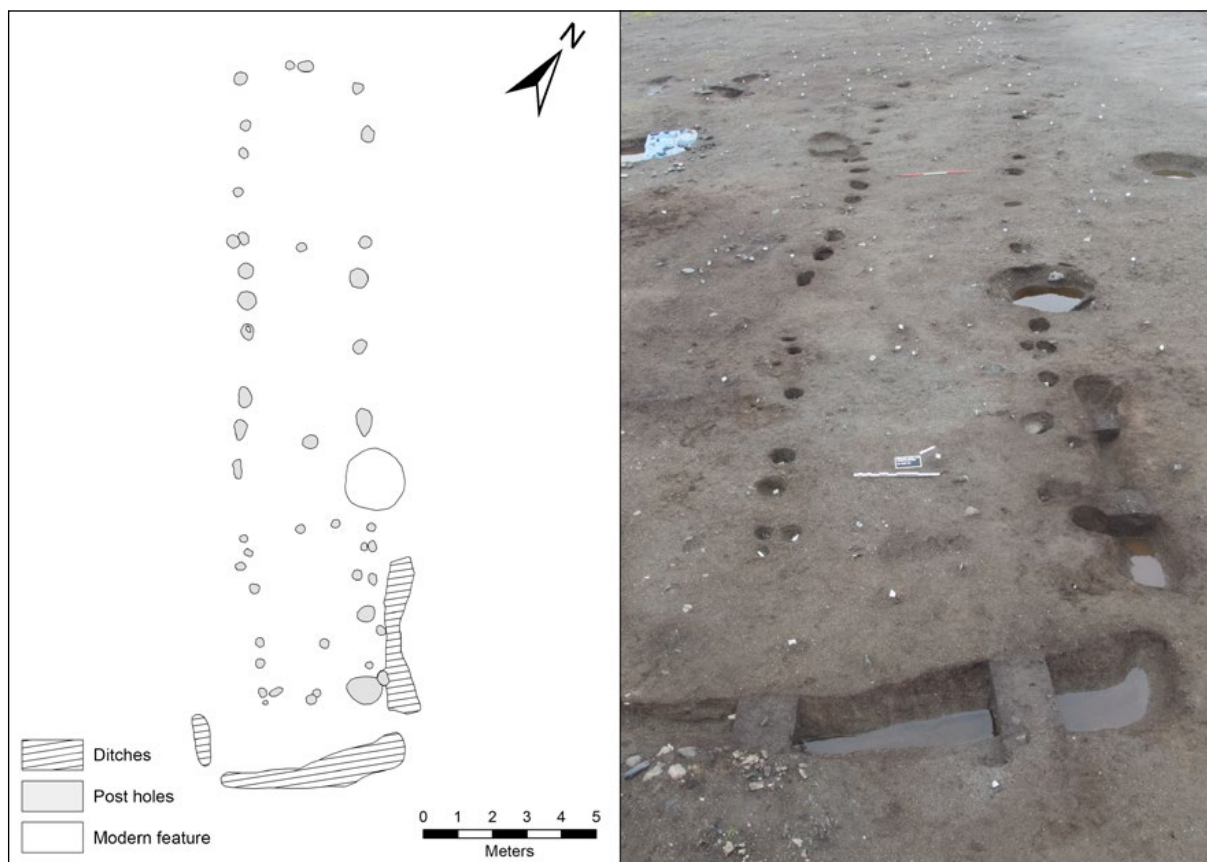
The early medieval House 20 was 18.5 meters long and had straight gable walls. The building was two-aisled with grounded posts along the external walls. The long walls were basically straight, but with some irregularities. The width of the house therefore varied between 3.5–3.9 meters (Figure 8). The house was built as a stave construction with roof supporting posts, timber frames and walls with either vertical or horizontal planks. In parts of Scandinavia, it has

Figure 8. House 20 in plan (left) and photographed towards the northwest (right), with drainage pits emptied. Illustration: Magnar Mojaren Gran, NTNU University museum.

been observed that there can be significant differences in the distance between the roof supporting posts. In House 20, the distance can be defined as short, which indicates that the sills that carried the plank walls were also short (Göthberg 2000: 81).

A single row of postholes ran along the longitudinal axis of the house. The distance between these posts was 5.3–5.8 m. Adjacent to the third center post from the northwest were a couple of shallow postholes which could represent an inner wall. On the southwestern long wall, west of the same center post, an unusually wide distance between the wall posts could indicate the location of an exterior door.

In the southeastern end of the longhouse was a parallel row of postholes along the exterior wall. This indicates repair, possibly due to the fact that the house had been exposed to moisture damage. Some of the early postholes were overlaid by one of three oval trenches. This shows that these three trenches did not form a part of the original longhouse, but that they were dug around the gable in connection with the repair of the house (Fransson & Mokkelbost 2018: 286–295, Figure 6.38).

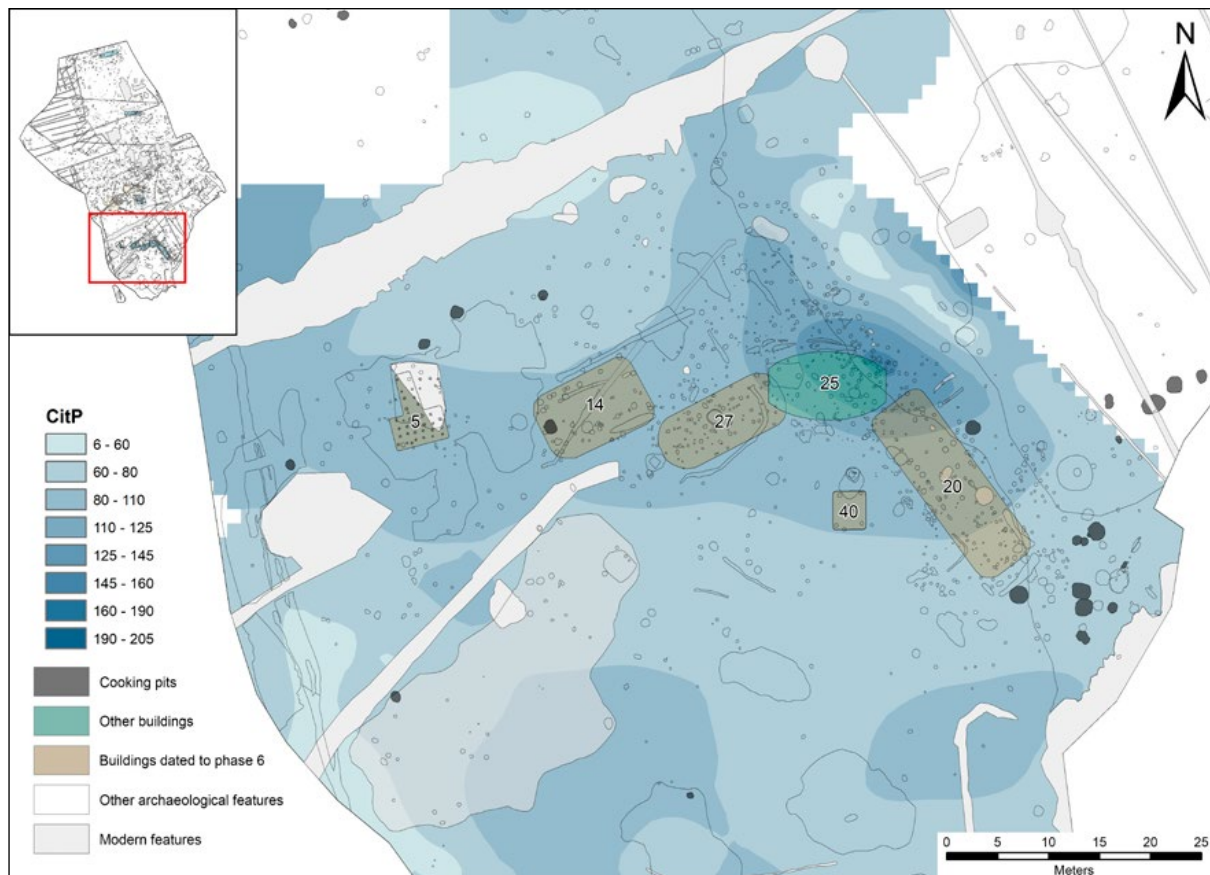
Figure 9. Soil phosphate mapping (Cit-P) of the southern parts of Fields E and A. Illustration: Magnar Mojaren Gran, NTNU University museum.

The comparatively low phosphate values (Figure 9) and the lack of macrofossil finds suggest that House 20 lacked a barn (Buckland et al. 2017: 75, Figure 67, Moltsen 2017: 9). Several studies in Scandinavia have pointed out that the barn was separated from the longhouse during the Viking Age. This forms part of a general trend where the older, three-aisled, multifunctional longhouse gradually splits up into several smaller buildings (Myhre 1980: 358, 368, Skre 1996: 63–65, Myrdal 2011: 91–92). This interpretation is strengthened by the fact that in the Danish material, single- and two-aisled longhouses

In the preserved parts of House 25, two hearths were excavated. The palaeobotanical analysis indicates that this part of the building had a residential function (Moltsen 2017: 16–17). At the same time, an area with very high phosphate values was measured directly east of the preserved parts of the building. If House 25 was, in fact, longer than 10 m, then the phosphates could indicate the location of a destroyed barn (Figure 9).

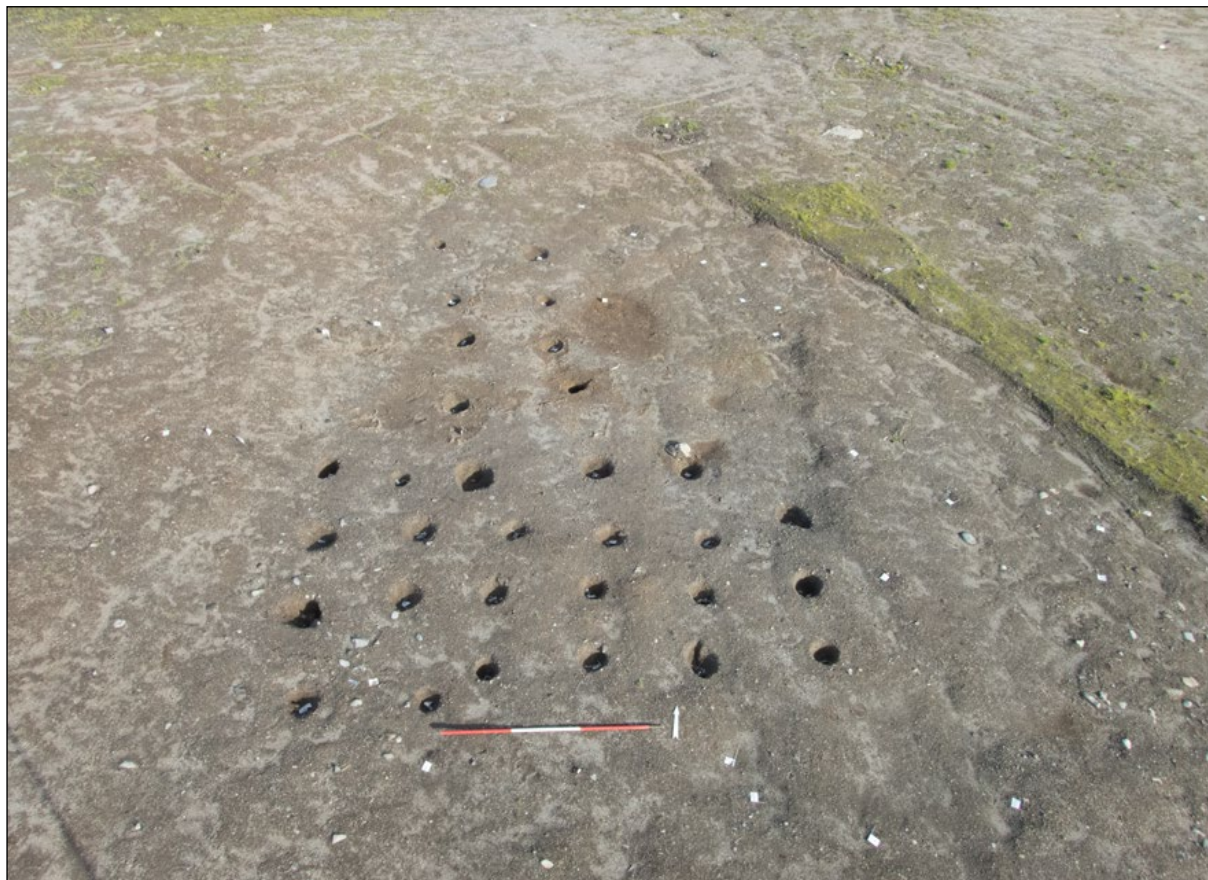
Figure 10. Photo showing House 5 after excavation. Photo NTNU University Museum.

West of House 14, House 5 was excavated. House 5 was situated in a humid place and consisted of 33 rather tightly placed postholes positioned in the shape of the letter T (Figure 10). Comparable constructions, called *Pfostenrosten*, and interpreted as the foundation for a raised platform or foundation in wood for warehouses or storage rooms, have been excavated in Denmark and northern Germany (Zimmermann 1992: 228–261, Abb. 191, 201, 204, Schütz & Frölund 2007: 163, Figures 3 & 6).

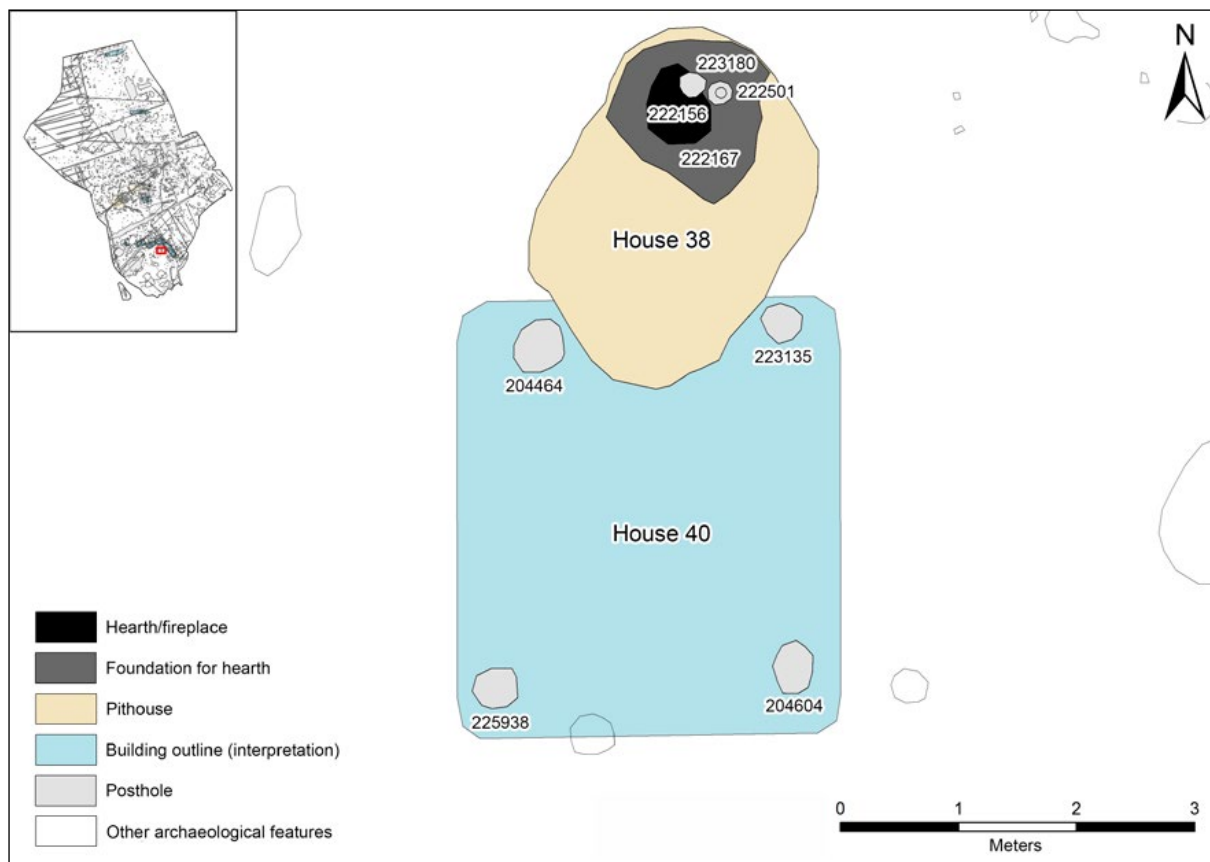
Ten meters west of House 20 a pit house, House 38, was excavated. It had a rectangular shape, 3 x 2.75 m in size (Figure 11). In the northern corner, the remains of a filling of soil and fire-cracked

stones was interpreted as the base for a hearth. The construction had originally been almost square and c. 20–25 cm thick. It probably consisted of a built-up earthen foundation with a wooden frame. On top of the base, a slightly oval hearth was preserved (Fransson & Mokkelbost 2018: 303–312). Similar features are known from Late Iron Age and early medieval period Norwegian and Swedish countryside contexts (Ramqvist 1998: 52–86, 139, Fig. 38, 40b, Skre 1996: 67, Sørheim 2003: 98–100, Finstad 2009: 115, 123–125, Fig. 2, 6–8). The use of timber in similar constructions in the region is evident from excavations at Foss Lian in Melhus, Trøndelag. Here a pit house with walls of timber logs has been dated to the Viking Age (Fretheim & Henriksen in prep.).

Figure 11. Pit house (House 38) and four-post building (House 40). Illustration: Magnar Mojaren Gran, NTNU University museum.

A small, rectangular building, House 40, lay directly south of the pit house (Figure 11). Three postholes with similar solid stone packings were excavated, and charcoal of pine from one of these has been dated to the same plateau in the ^{14}C -curve as the pit house. It is therefore not possible to determine which of the buildings is the earliest (Fransson & Møkkelbost 2018: 312–314). However, the two houses indicate that the area was used for several different activities.

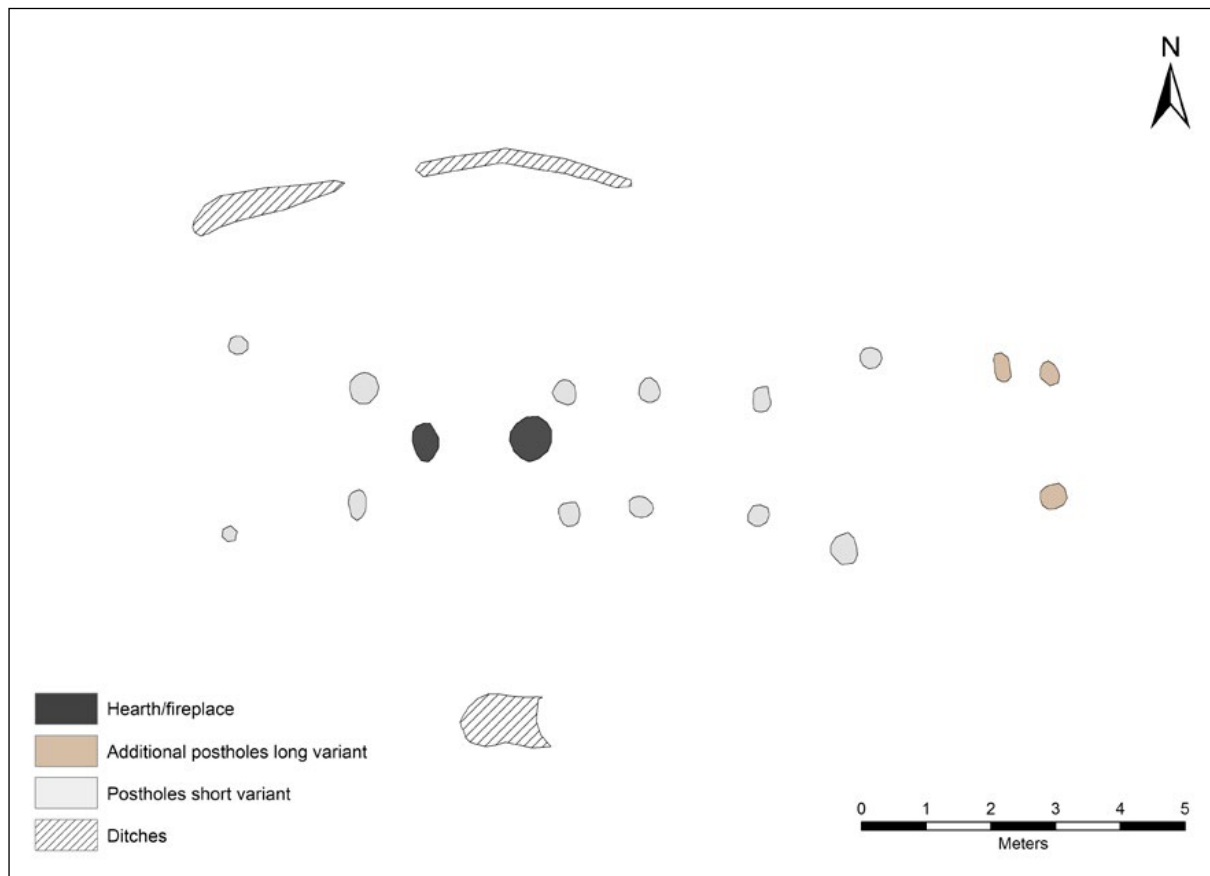
House 25 was built in an east-west direction. The central aisle was c. 1.8 meters wide, but the last trestle in the west was nearly three meters wide. This probably constituted the gable posts. In the east, the building bordered on an area disturbed by the modern gravel pit in the eastern part of Field E (Figure 3 and 4). A pair of postholes in the eastern part of House 25 may have been gable posts. Based on this reconstruction, House 25 was approximately 10 m long. However, postholes excavated and dated in the damaged area east of the building indicate that House 25 could have been 5–10 m longer (Figure 13).

Figure 13. House 25, two interpretations. Illustration: Magnar Mojaren Gran, NTNU University museum.

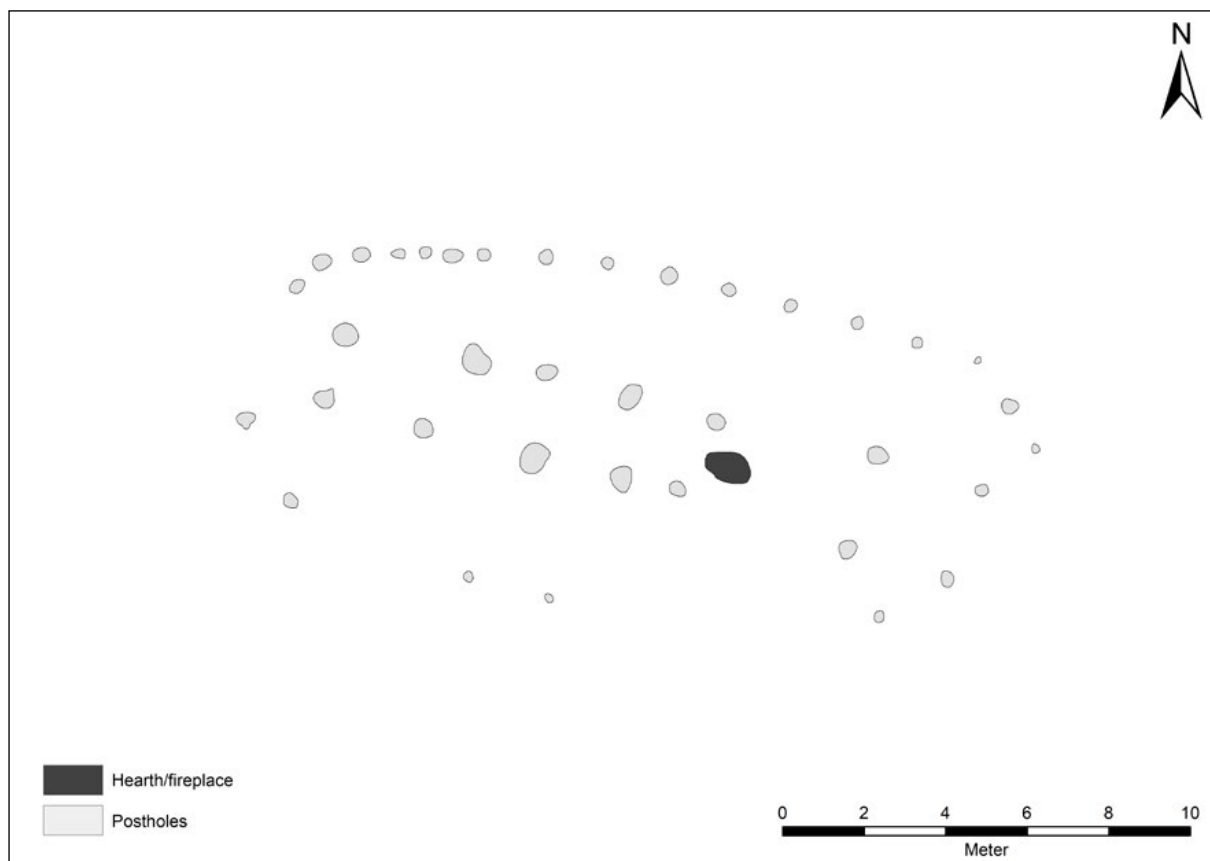
Figure 14. House 1 at Hårberg. Illustration: Magnar Mojaren Gran, NTNU University museum after Birgisdottir and Rullestad 2010.

into the subsoil. The exterior wall on the southern side was poorly preserved but had a similar shape (Figure 14). The longhouse was 20 m long, and the central part had a width of 8.5 meters. Three ¹⁴C analyses, two from postholes and one from the central hearth, were all within the time span of AD 655–785 (Birgisdottir & Rullestad 2010: 10–12, Appendix 9). The dates clearly indicate that the longhouse is from the Merovingian period, most likely from its second half.

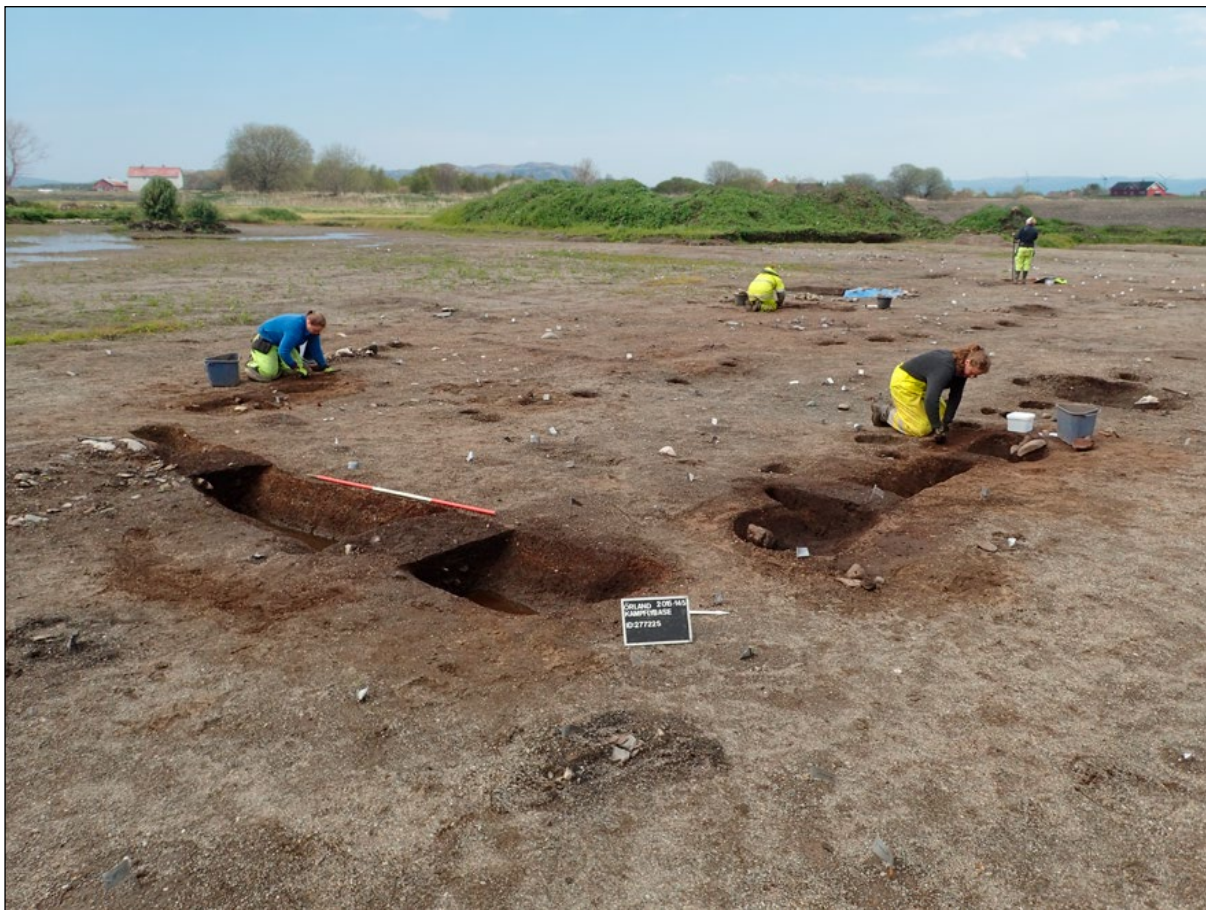
Figure 16. Excavation of the large ditches at the southeast end of House 20. Photo: NTNU University Museum.
