CHAPTER 2

St Olav's Church in Tønsberg. The Excavation of 1969–70 in Retrospect

Øivind Lunde

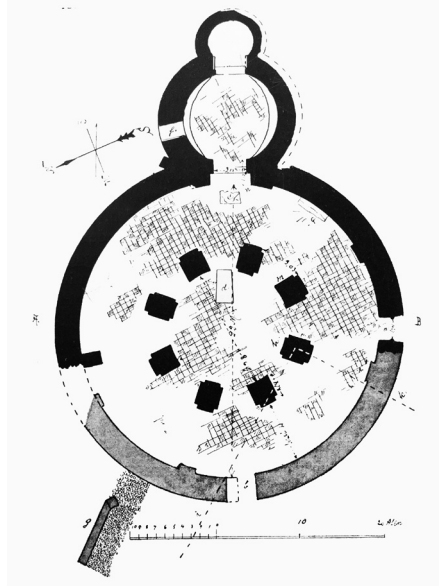
Figure 2a. Plan of the church and section through the church marked A–B. Illustration: H. Thorsen.

The first excavation of St Olav's church in 1877–78 took place after the original site and remains of the church had been discovered when a new building was being planned. The western part of the original church had for the most part disappeared, but architect H. Thorsen was able to draw the ground plan, a section and other details (fig. 2a–c). He left his

documentation to Hugo Frölén who included it in his study ‘Nordic fortified round churches’ (in Swedish), published 1911. We can here see that he found floor-tiles, but also that he did not dig any deeper than that level. The section with an east-west orientation tells us what was left of the round building in 1878. The southwest doorway was later removed.

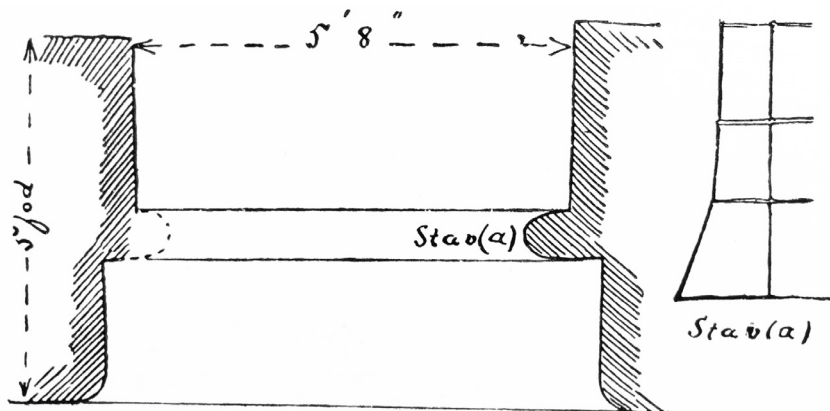
Figure 2b. Later destroyed south doorway marked B on the plan. Illustration: H. Thorsen.

Only the northern and southern doorways in the round church are documented. The southern doorway, destroyed after 1878, was very similar to the northern one. The northern doorway has survived, but it must have been blocked relatively early since the threshold is hardly used. However, the fact that there are no traces of any blocking could indicate that this door had rarely been in use. There was probably, in the late medieval period, an altar near the doorway with a platform in front of the doorway (fig. 13a). There are remains of the old wooden floor under yellow sand at the sides of this platform and over the final tile-floor. In this final floor there is a marble slab with a kind of lily cross (fig. 13b).

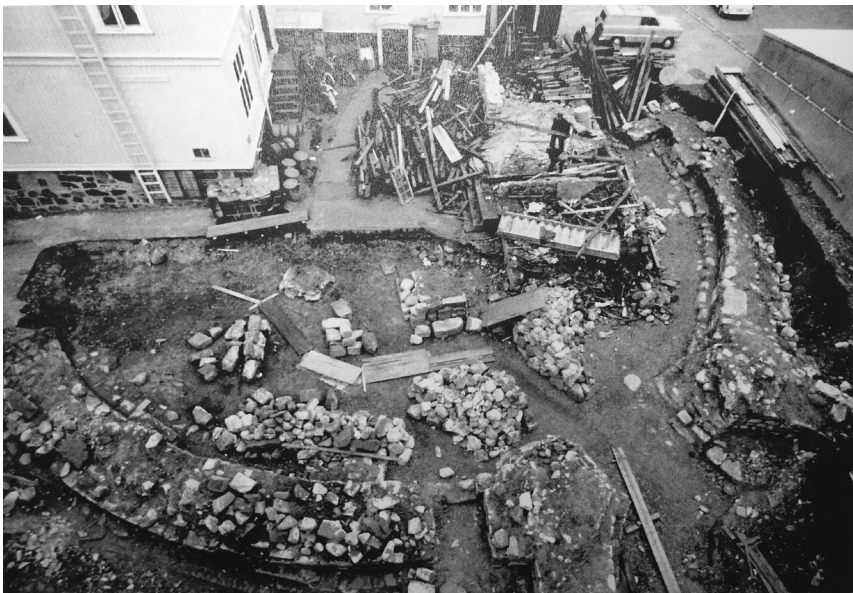
Figure 3a. Exposure of the ruin under older buildings in 1964. Photo: Jan Greve/NTB.

Tønsberg Sparebank (Tønsberg Savings Bank) bought the whole property in 1963 and made it possible to initiate a project for exposing the old church ruin, conserve it and carry out excavations (fig. 3). Bernt C. Lange from Riksantikvaren (Norwegian Directorate for Cultural Heritage), was responsible for the project, which lasted five years. His first step was to excavate the rubble from 1878, and he found what was left of the ruin. The rubble contained many original stones from the

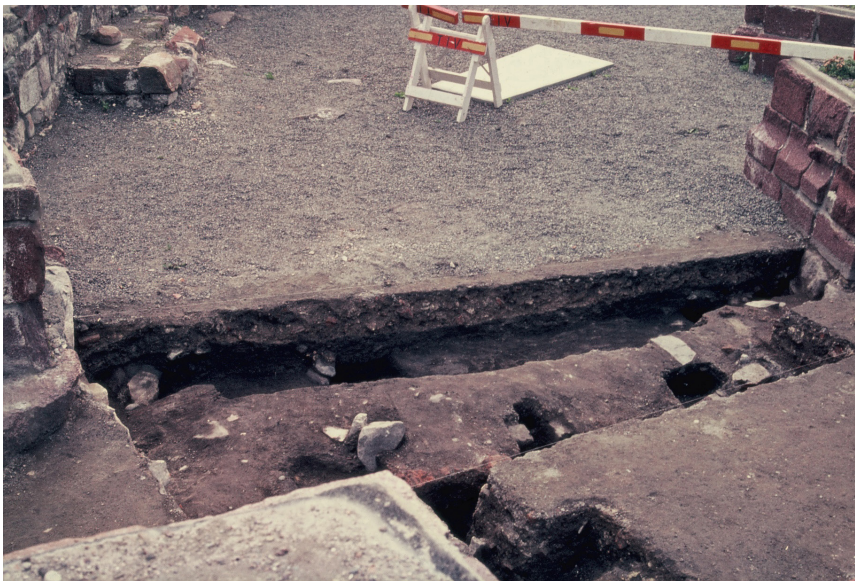
Figure 5b. Trench 4:69 between pier P3 right and the entrance to the Chancel left, facing south. Photo: Ø. Lunde.

We had this black layer nearly everywhere, and above it, in the southern and eastern sections, a building-layer without traces of bricks or datable finds (fig. 5a, b). In the northwest we had yellow-grey sand over the black layer. Above this level the layers are more complex and vary from place to place because of graves, constructions, and floor-repair (fig. 5c).

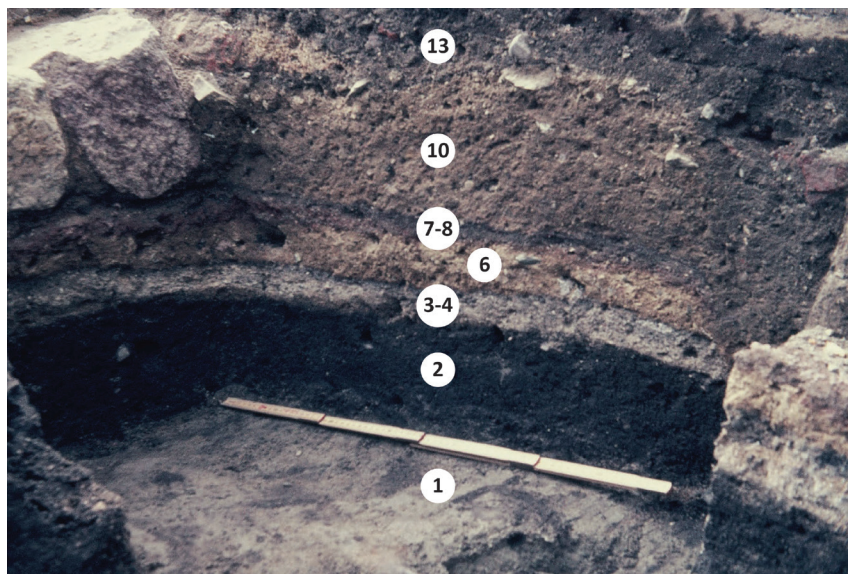
Figure 5c. Trench S1:70, West of pier P3 with remains of an altar in the central room: Layers from bottom and up: 1) original ground, 2) black layer, agricultural soil, 3–4) building layer with sand, chalk, chips of red stone with a darker thin level on top before next layer, (5) not used here, 6) yellow sand, 7–8) darker level on top of 6 with red stonechips and dark earth on top with bits of wood. Probably a floor of wood above that later was removed. 10) yellow sand perhaps to fill up to the new floor level of glazed tiles. 13) Grey sandy soil. Photo: Ø. Lunde.

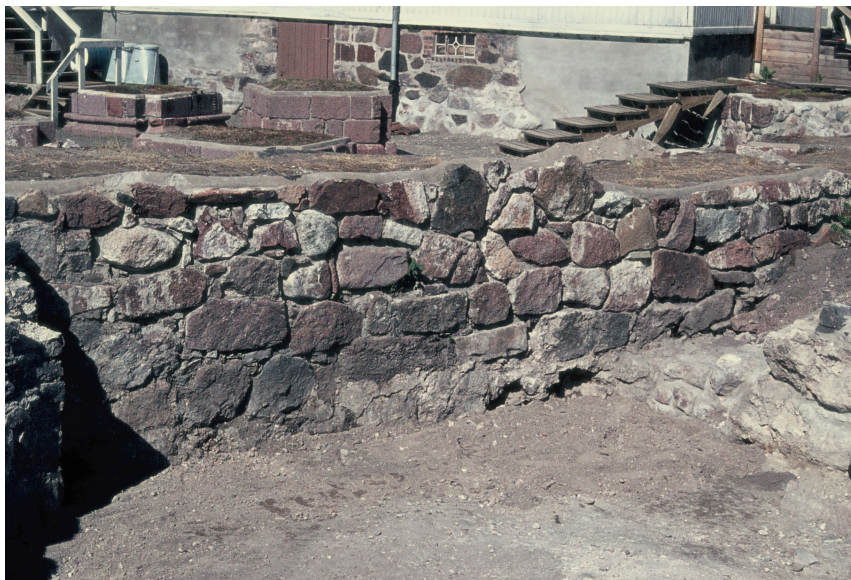
Figure 7. Roundhouse wall in northeast from inside in the sacristy. Photo: Ø. Lunde.

- The roundhouse wall is 1,80m wide and built as a cavity wall of red local granite with rough-hewn square stones in relatively even layers.
- The northeast wall (fig. 7) and the lower southeast wall are relatively well preserved.
- The entrance to the chancel is restored, but the opening can be estimated to 3,5m.

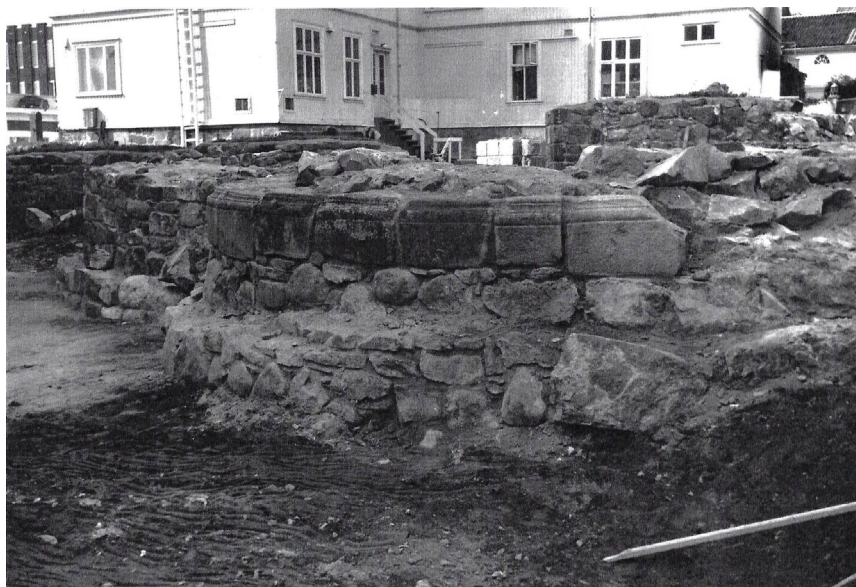
Figure 8a. Apse from outside with the original profiled stones. Photo: Ø. Lunde/Riksantikvaren.

- The walls in the chancel are 1,50m and the apse and the sacristy 1,20m.
- Part of the chancel walls has been restored from the foundations where traces on the stones gave the alignment. Original profile-stones that had finished the wall over the foundation were found and reused. (fig. 8a, b).

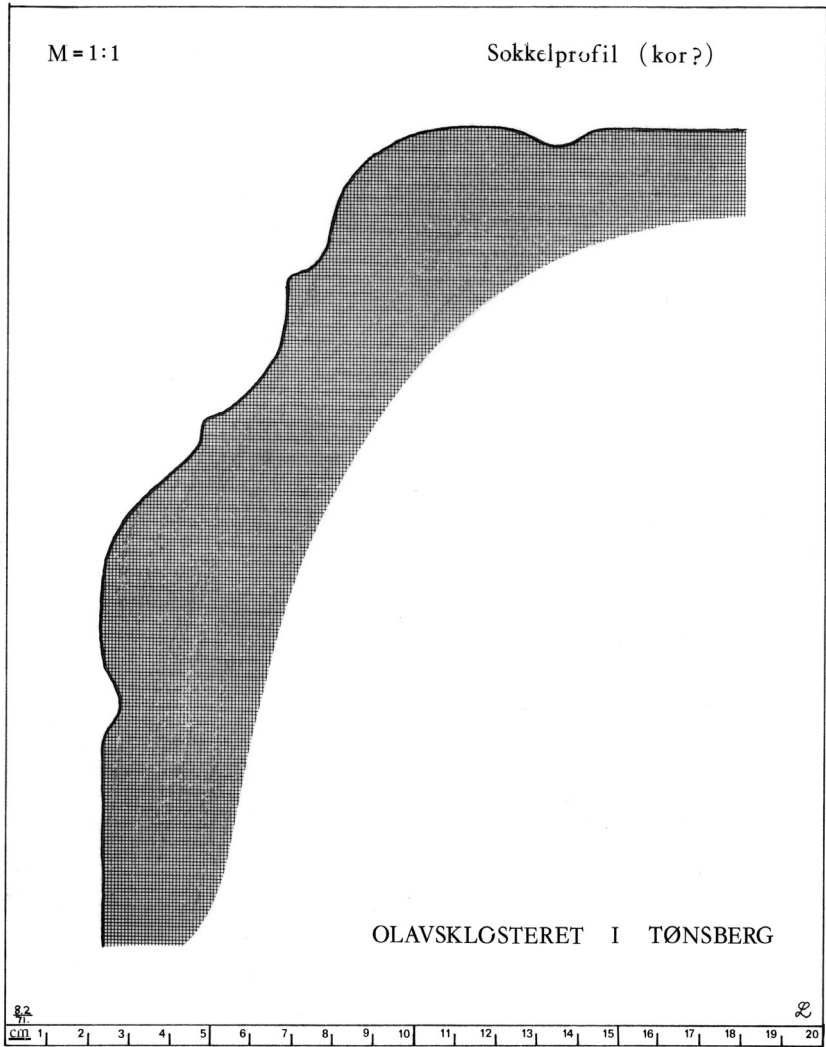
Figure 8b. Base profile around the apsis wall. Illustration: Ø. Lunde.

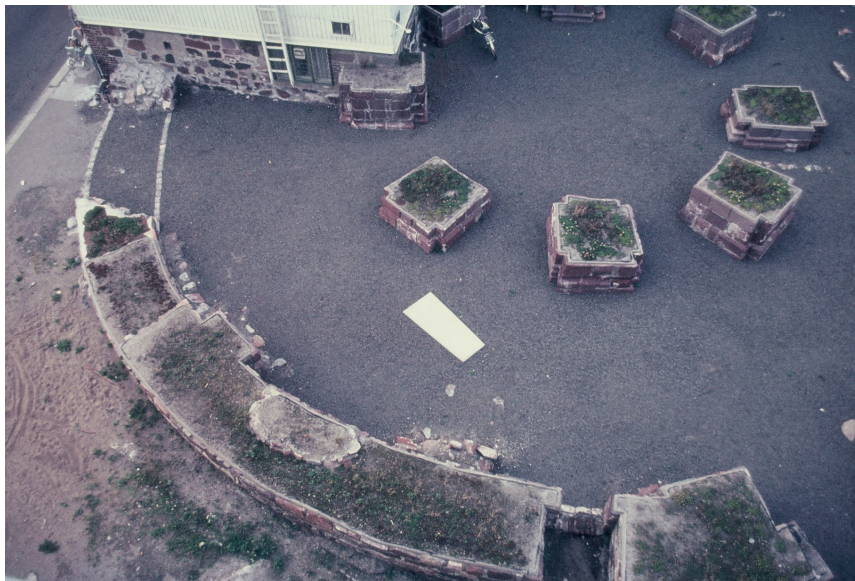
Figure 9a. Eastern part of the roundhouse and entrance to the Chancel. Photo: Ø. Lunde.

The eight square columns in the roundhouse are restored from the first course of stones that had survived demolition (fig. 9a). Most of the stones used in the restoration were found in the rubble. The profiled bases of the columns could be reconstructed with mostly original stones (fig. 9b).

The third opening in the southeast next to the chancel is a simpler doorway that must have been the entrance from the monastery. It is important to note that the door opened out of the church and the door could be bolted from the outside, that is from the monastery (fig. 6 and fig. 9a). This doorway has been rebuilt several times and could have been in use after the medieval period.

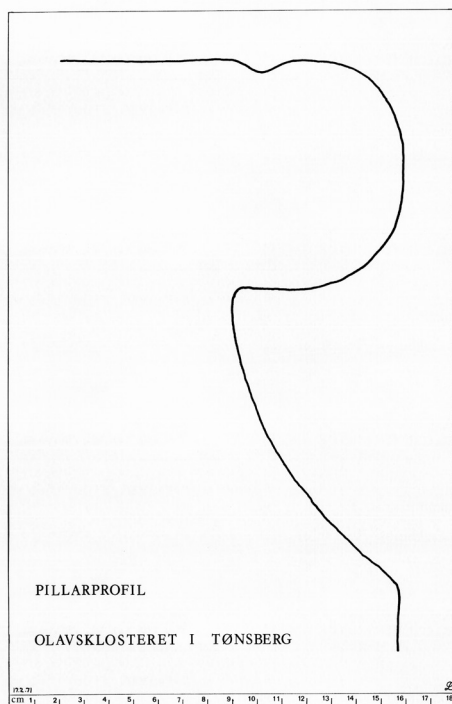
Figure 9b. Base profile used on the piers. Illustration: Ø. Lunde.

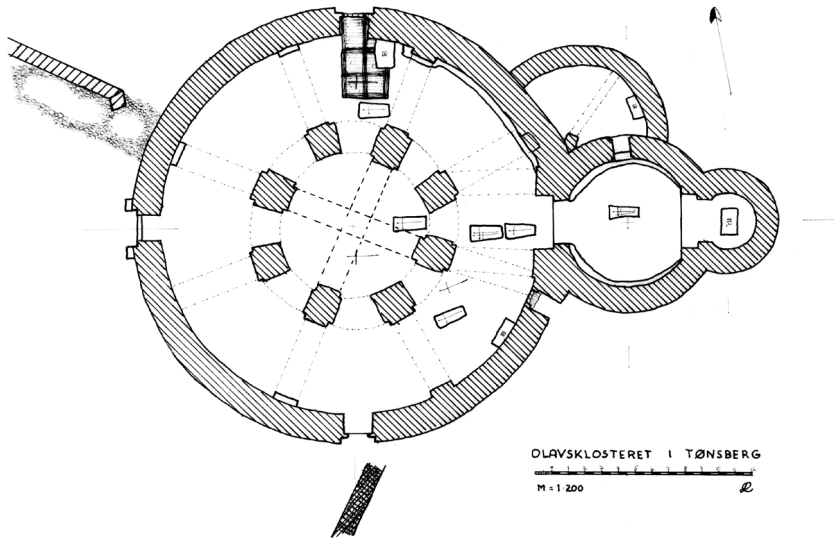
Figure 10. Church-plan with arches for the vaulting. Illustration: Ø. Lunde.

Every second column had pilasters on all four sides, while the other four columns only had pilasters on two sides which supported the arches between the columns. The columns with four pilasters supported arches over the central room and over to the outer wall in the ambulatory as well as the arches between the columns. At the outer round wall there are pilasters that would meet the arches in the ambulatory (fig. 10).

Finds of coins suggest the late medieval period for the platform and altar at the north doorway (fig. 10).

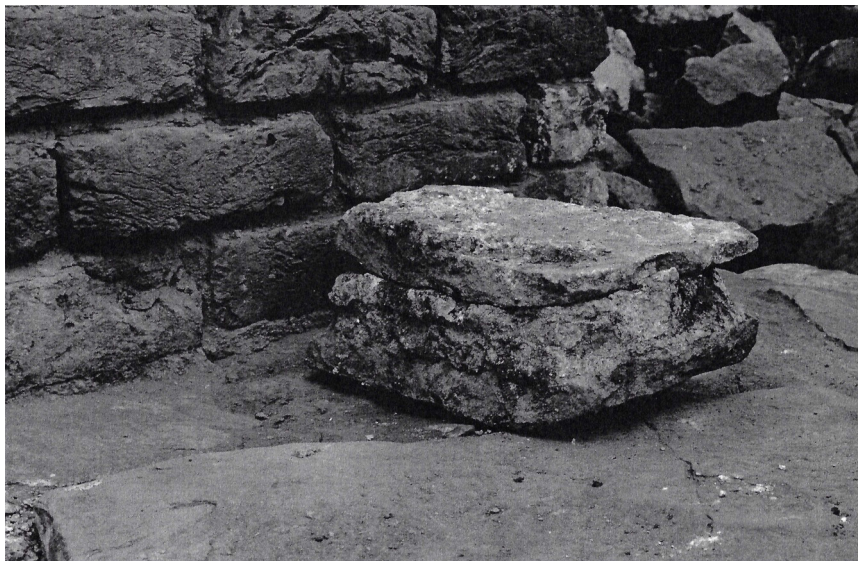
Figure 11. Part of vaulting found 1970. Photo: Ø. Lunde.

Two crossing arches could have been carrying a vault in the central room. In both 1878 and in 1970 parts of arches were found (fig. 11). The vaulting in the central room, chancel and vestry could have been part of the first phase of building, but it is difficult to prove this. Since molded bricks shaped to be part of a vault were found where they meet the walls, it is reasonable to suggest that the ambulatory has been vaulted at a later stage.

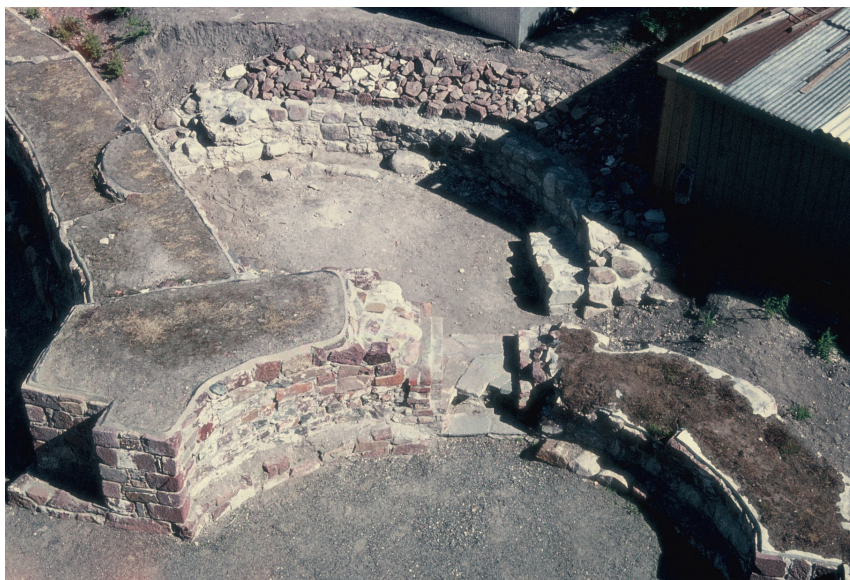
Figure 12. The vestry reconstructed 1970. Photo: Ø. Lunde.

The arches between the central room and the outer wall, intended to lead the forces of weight, are probably from the first building phase. We know the vestry has been vaulted with one arch from the corner between the roundhouse and chancel and the outer wall (fig. 12). We have found parts of the arch there. This is the same construction as they found between two of the columns in 1878.

From the chancel we have traces of two doorways to the vestry above each other. They correspond with the two floor levels here (fig. 12). We found no traces of any other doorway to the vestry.

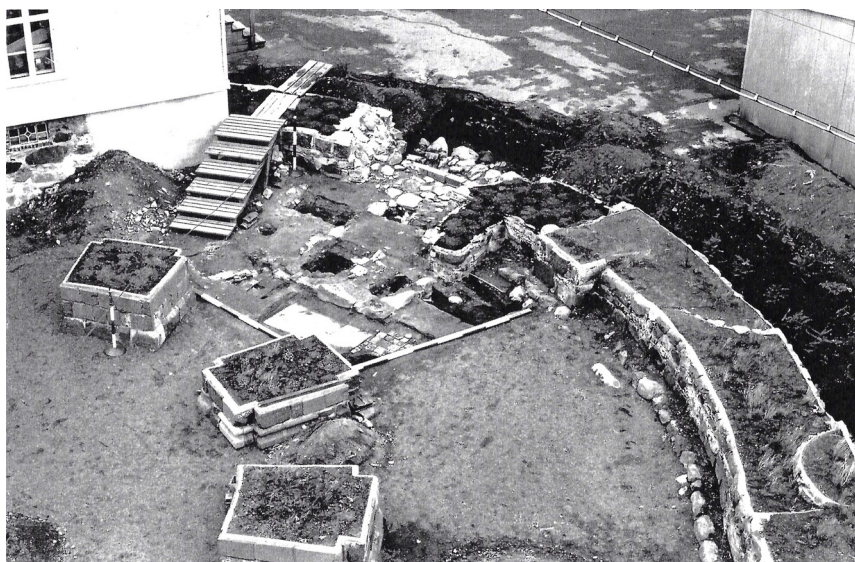
Figure 13a. North doorway and the ambulatory with tile-floor, grave slab and platform with altar.
Photo: Ø. Lunde.

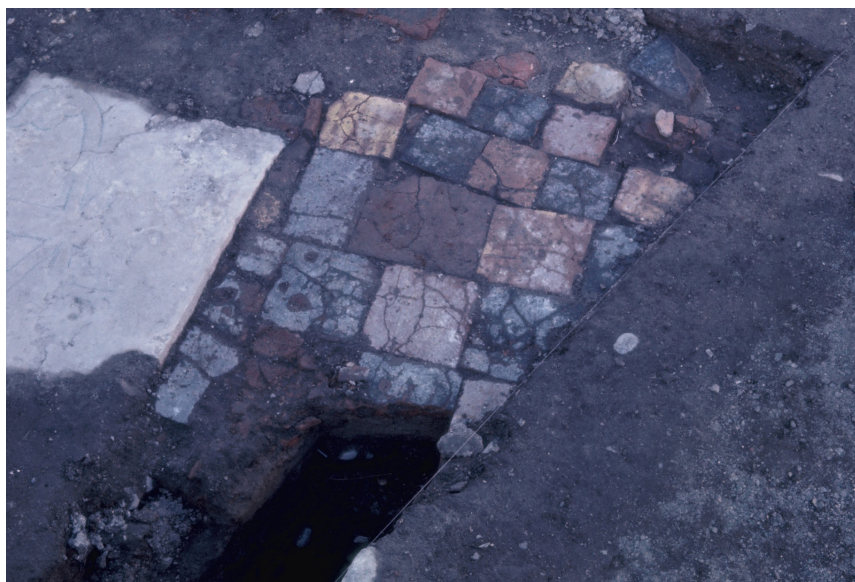
Figure 13b. Detail of 13a with the grave slab with a kind of lily cross and the last glazed tile-floor.
Photo: Ø. Lunde.

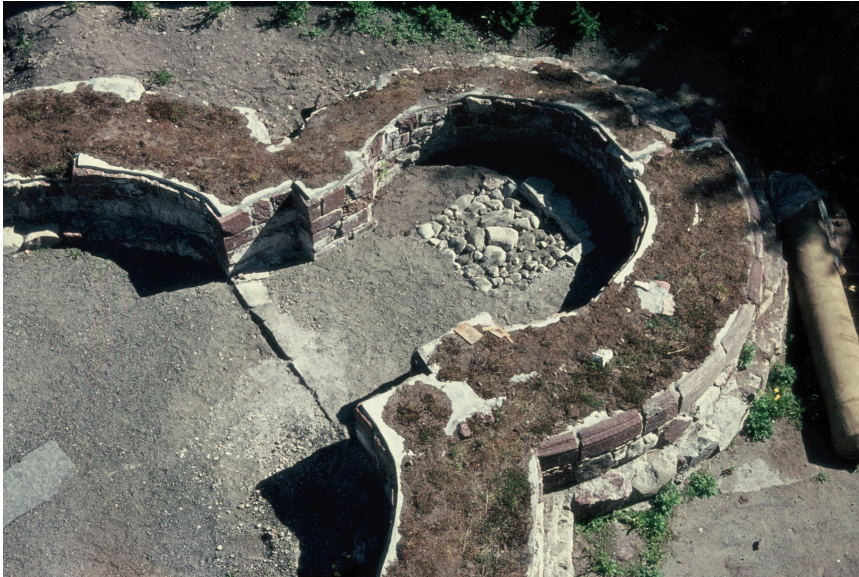
Figure 14a. Main altar in the apse after excavation. Photo: Ø. Lunde.

The main altar in the apse has a very elaborate construction (fig. 14a). It is made as a small chamber with well-made sides filled with mostly

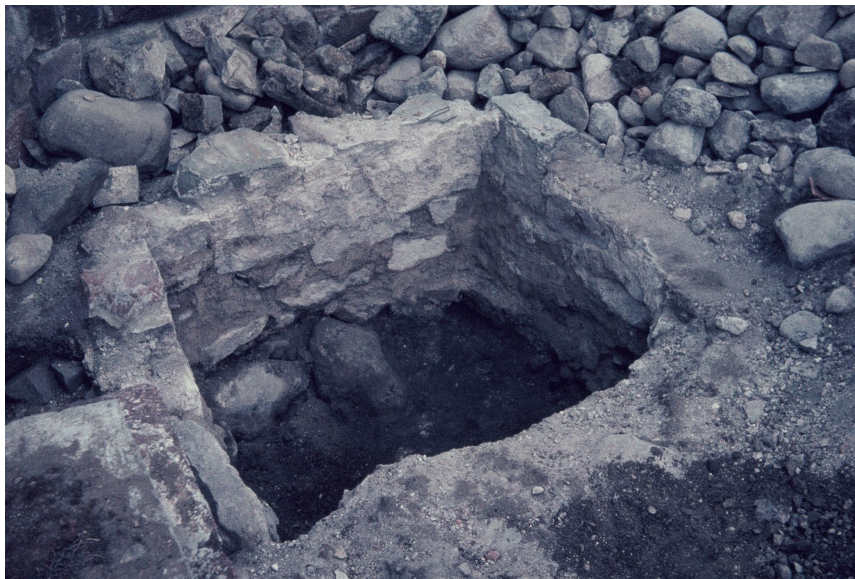
Figure 14b. Main altar in the apse from northwest during excavation. The water washed stones between the chamber's walls and the apse wall comes from the chamber. Under the stones it was a layer of lime over big lumps of iron slag set on a layer of gravel and more lime on soil, gravel and chips from stones cutting over the foundation stones for the apse. Photo: Ø. Lunde.

water washed stones (fig. 14b). Under it was a layer of lime over big lumps of iron slag on a layer of gravel and more lime. Then, over the foundation stones for the apse, lay soil, gravel, and chips and fragments from stone-cutting.

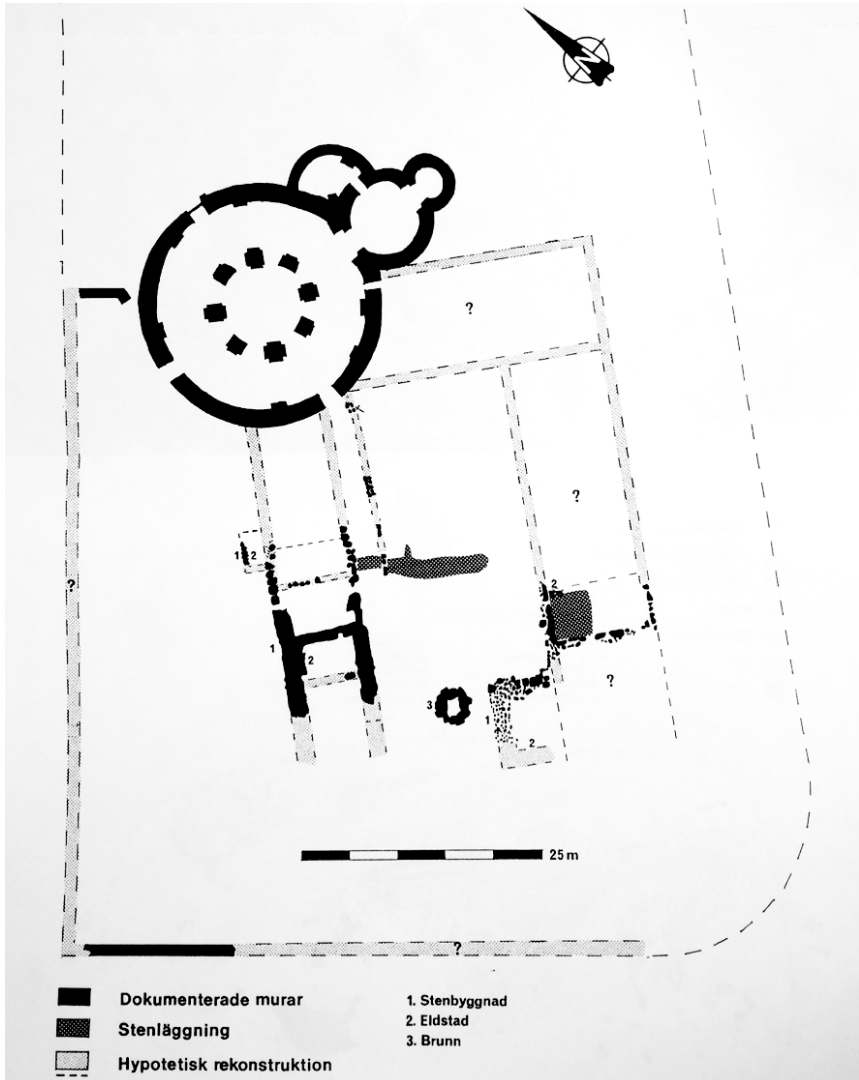
Figure 15. Plan of the church with remains of the monastery at the south side of the church. Remains can be seen in the library. Illustration: Dan Petterson.

One of the leaders of the excavation, Dan Petterson, made a reconstruction of the remains of the monastery south of the church. This reconstruction includes the area north of the church, and it suggests that there was a graveyard there (fig. 15).

It is difficult to understand how the buildings were organized within the monastery that probably owned the ground further south and southwest to the fjord. The reconstruction shows a long building leading from the church to the remains of walls a bit further south.

What this reconstruction shows could be the west-wing of the monastery. East of these remains, there is a well and remains of walls and floors.
